## **Asbestos & Lead Based Paint Assessment**

City of Spartanburg  
187 Sunny Street  
Spartanburg, South Carolina

Project Number: 0815-163

September 16, 2015

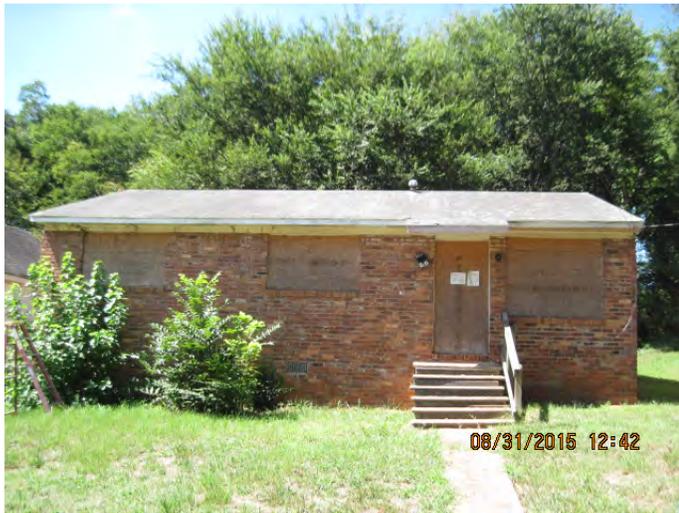
Photo 1 -- Front Elevation

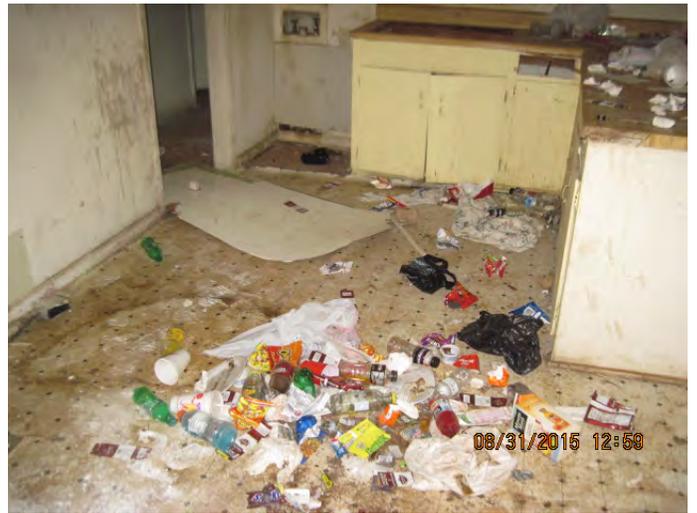
Photo 2 – Kitchen Vinyl Flooring

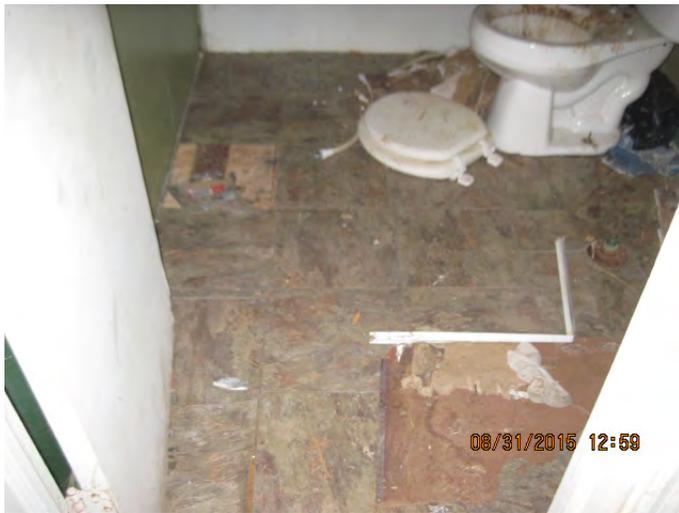
Photo 3 – Bathroom Vinyl Tile Flooring

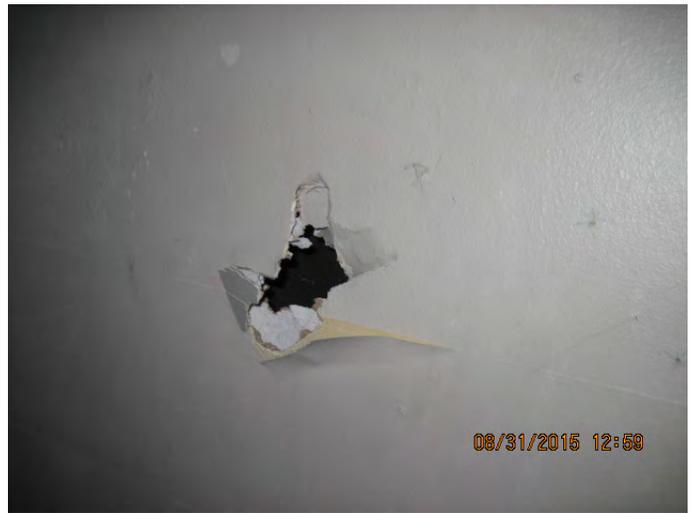
- Drywall and Joint Compound

| Sample No. | Location | Sample Description | Analytical Results | Friable/Non Friable | Condition | Quantity |
|---|---|---|---|---|---|---|
| 7 | Throughout | Drywall and Joint Compound | 2% Chrysotile (Joint Compound) | Friable | Good | 2000 SF |

Photo 4 – Drywall Wall with Joint Compound

1. Abate the asbestos containing materials in the structure prior to renovation or demolition.
2. Follow applicable asbestos regulations during renovation or demolition of the structure. You should be aware that stringent requirements are imposed upon anyone renovating or demolishing a structure in which ACM will be disturbed. This work must be performed in accordance with OSHA asbestos regulations, 29 CFR 1910 & 1926, and NESHAP asbestos regulations 40 CFR 61, subpart M. South Carolina regulations require the accreditation of personnel who work in the asbestos field and notification and permitting fees for asbestos removal projects. There is a 10 working day notification period required prior to abatement of asbestos in a facility. Failure to take proper precautions and actions to protect human health and the environment can result in penalties, danger to personnel, and construction delays.

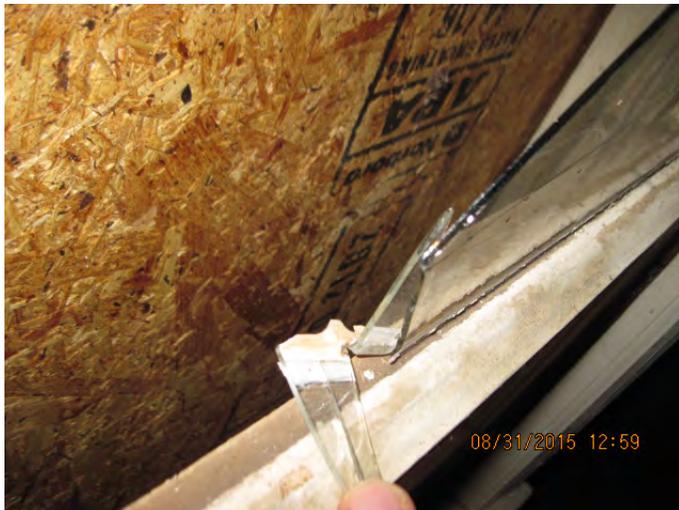
Photo 5 – Window Caulk

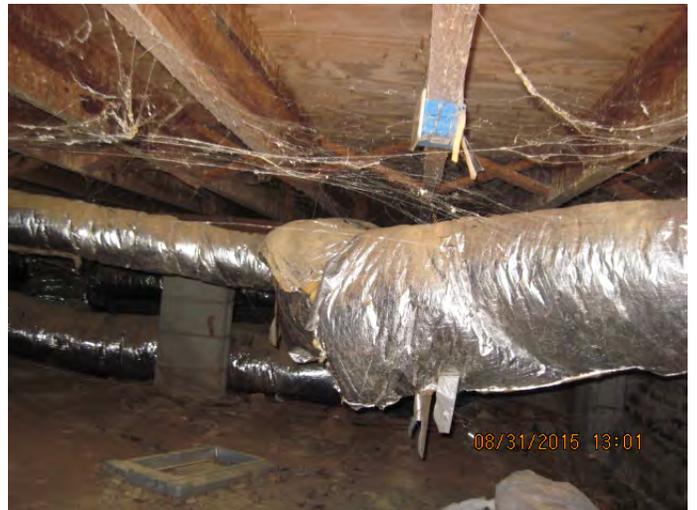
Photo 6 – Crawlspace

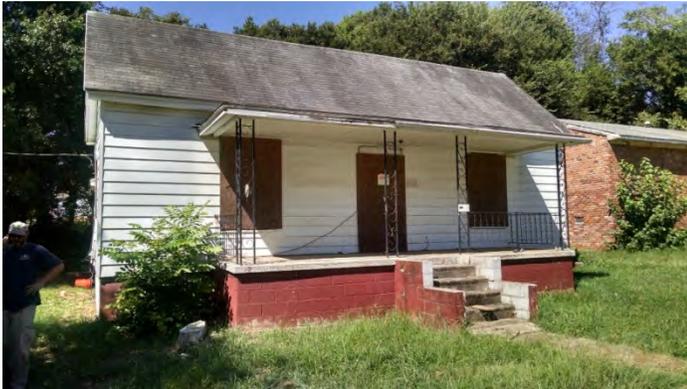
Photo 1 -- Front Elevation

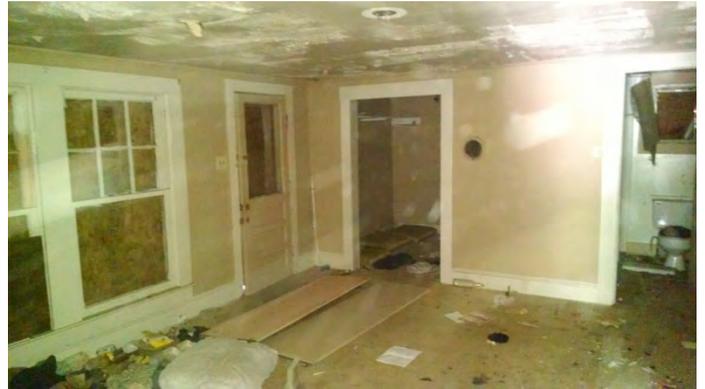
Photo 2 – Living Room

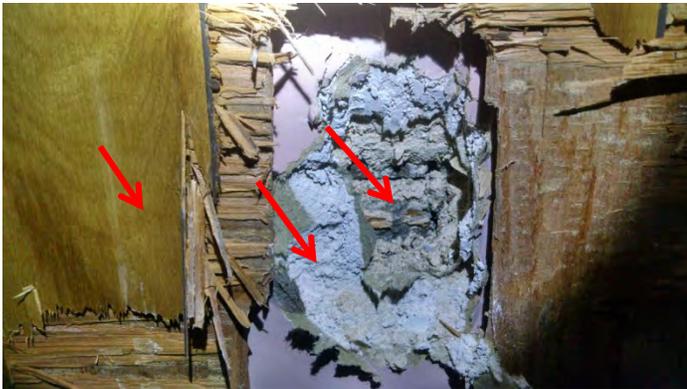
Photo 3 – Wood Paneling over Drywall over Plaster

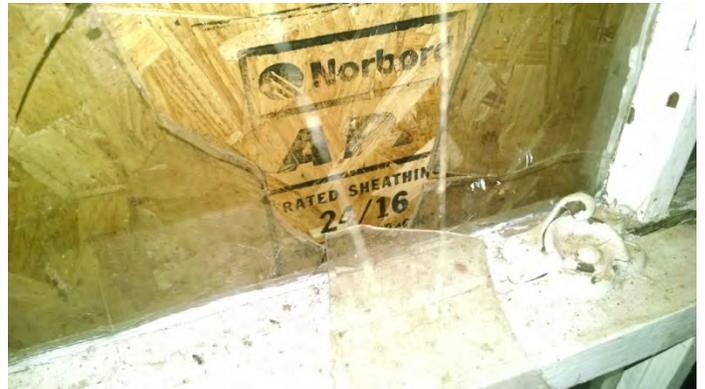
Photo 4 – Window Caulk

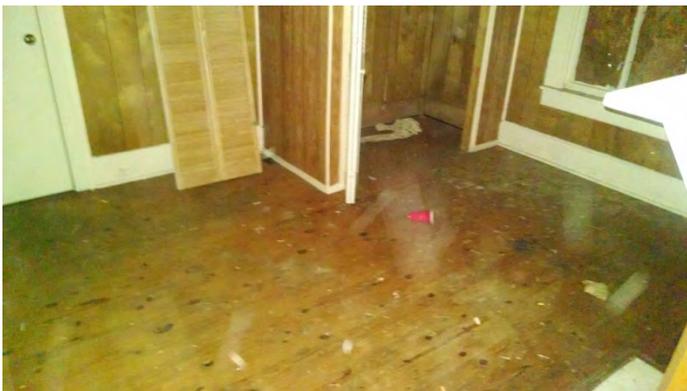
Photo 5 – Wood Flooring

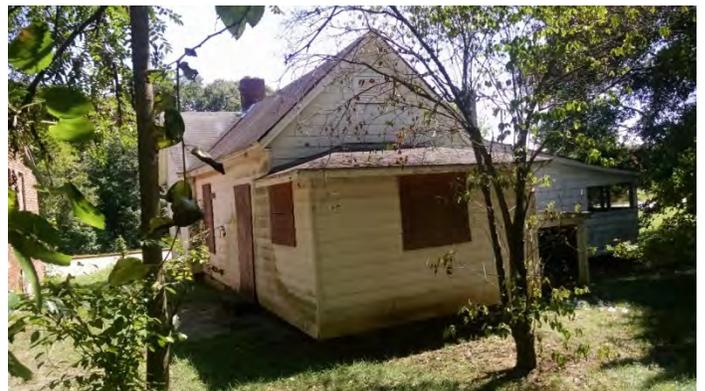
Photo 6 – Rear Elevation

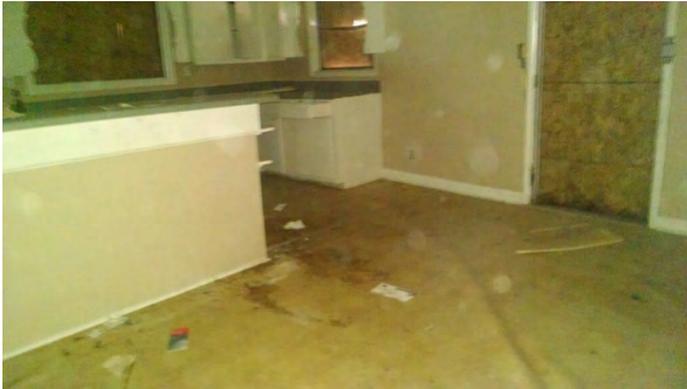
Photo 7 – Kitchen Vinyl Flooring

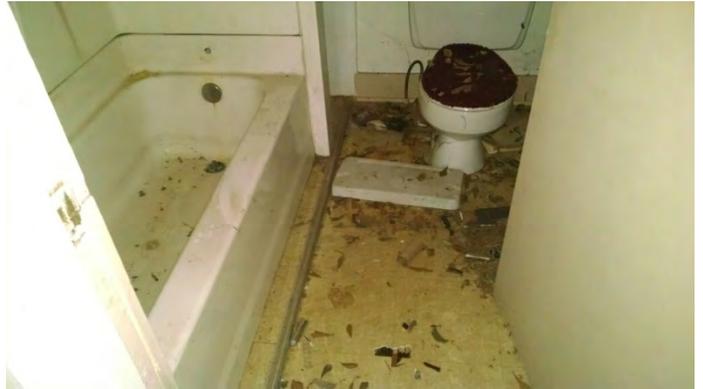
Photo 8 – Bathroom 12"x12" Vinyl Tile Flooring

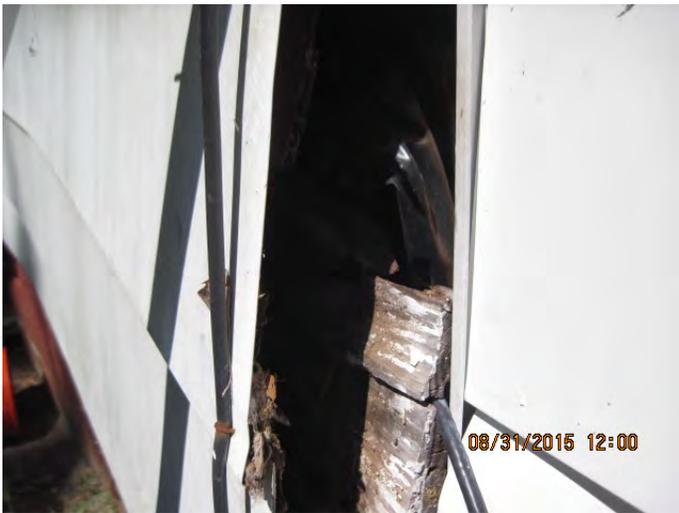
Photo 9 – Metal Siding over Wood.

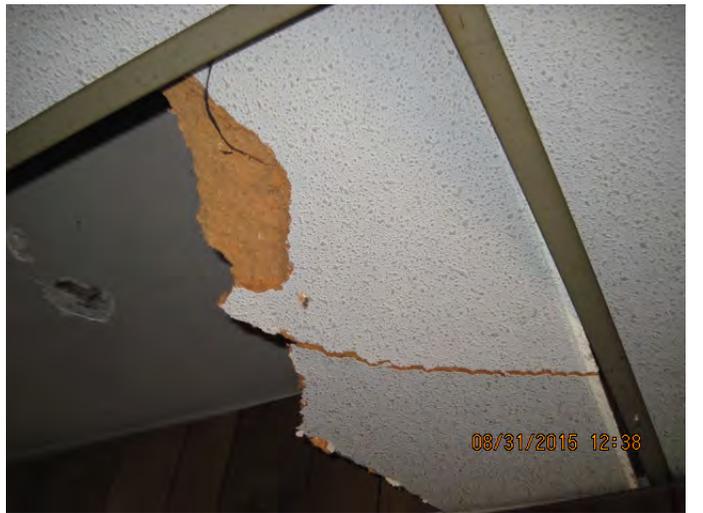
Photo 10-- Drop ceiling

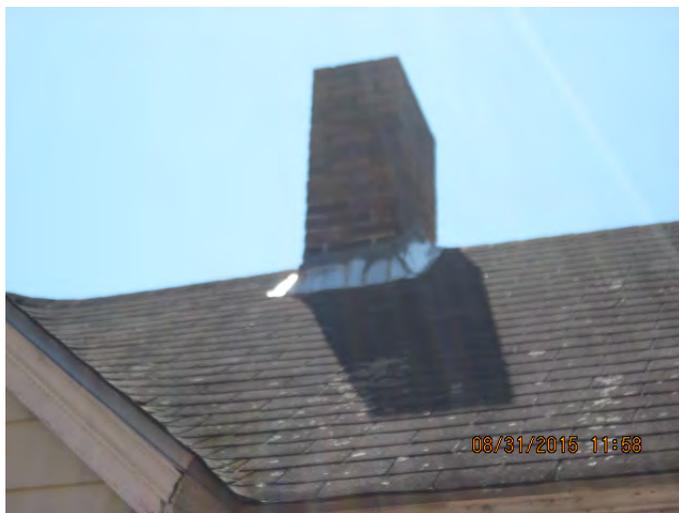
Photo 11 – Chimney with Assumed Caulk.

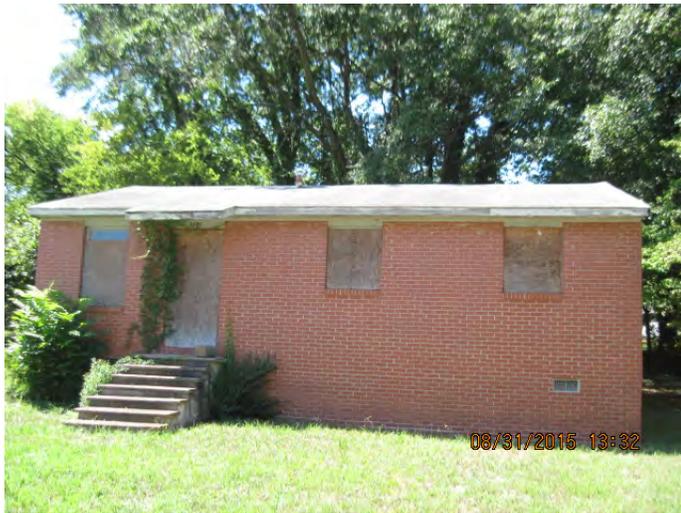
Photo 1 -- Front Elevation

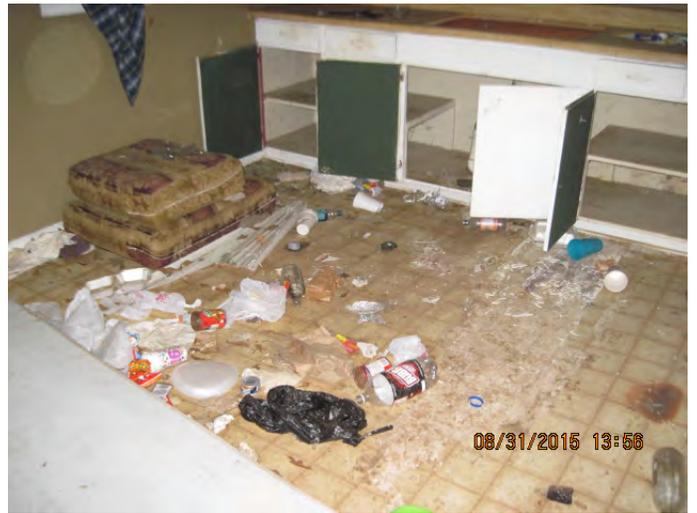
Photo 2 – Kitchen Vinyl Flooring

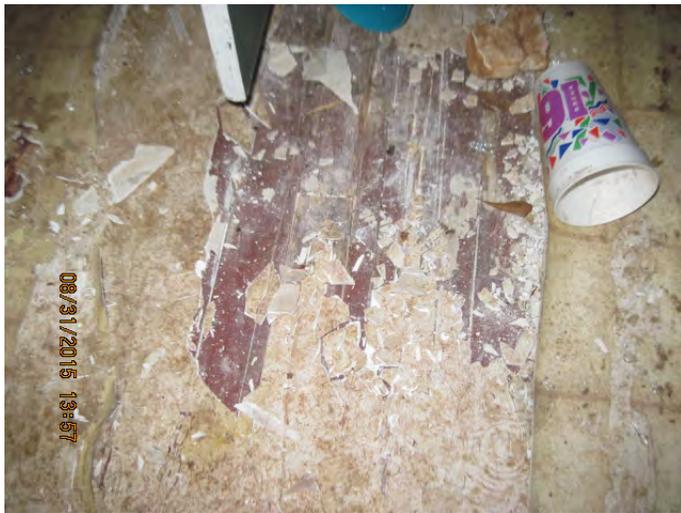
Photo 3 – Kitchen Leveling Compound Under Vinyl Flooring

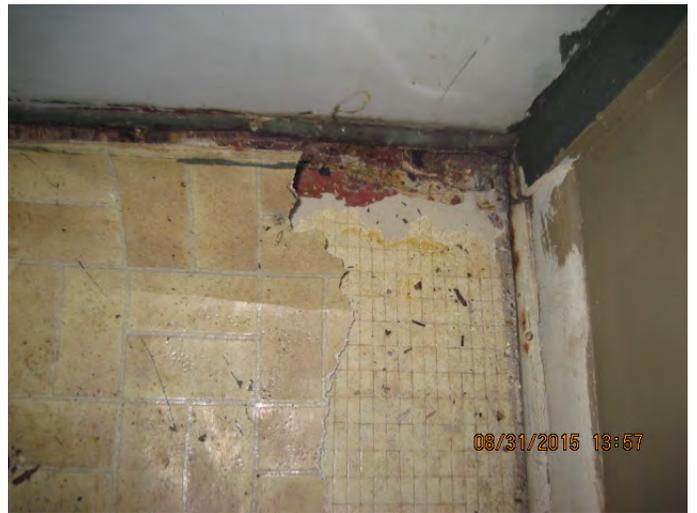
Photo 4 – Two Layers Vinyl Flooring in Bathroom

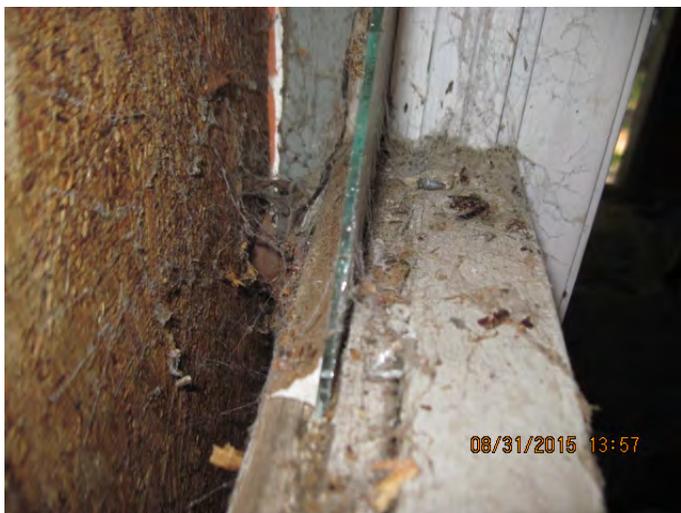
Photo 5 – Window Caulk

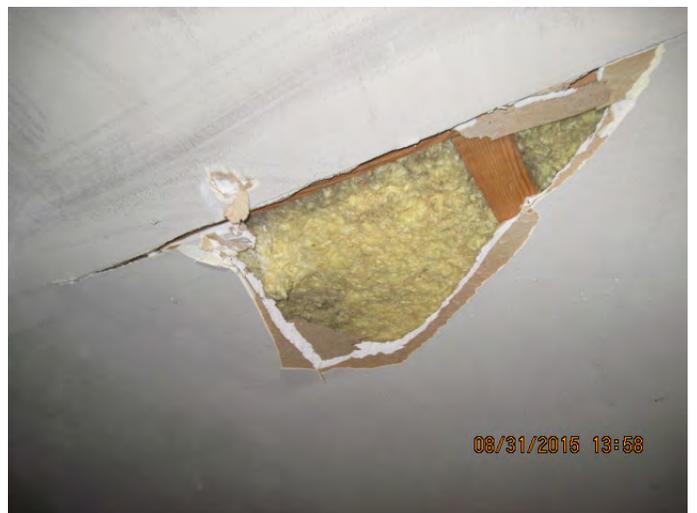
Photo 6 – Drywall

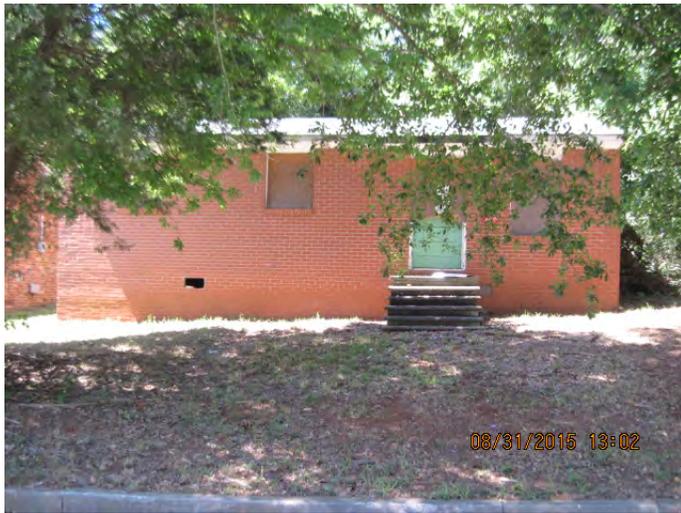
Photo 1 -- Front Elevation

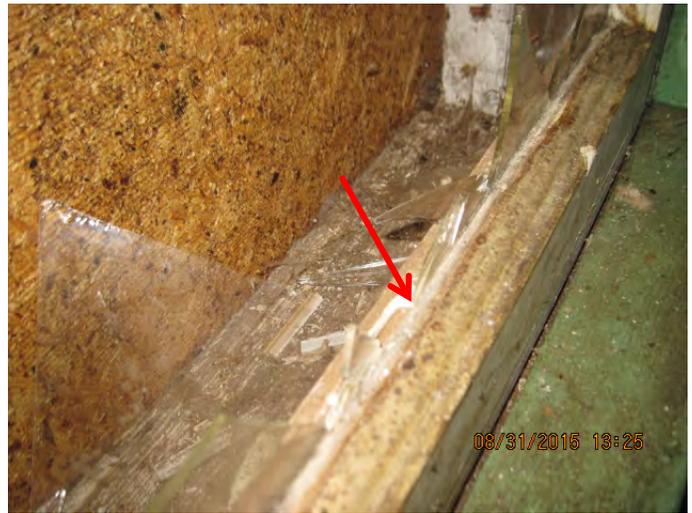
Photo 2 – Window Glaze

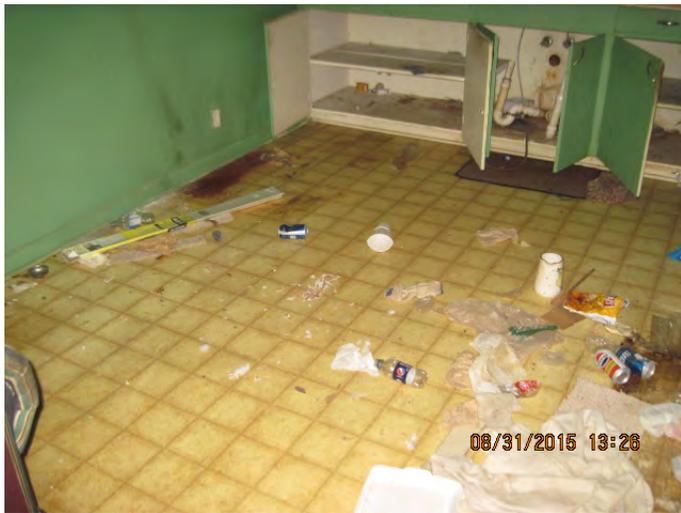
Photo 3 – Kitchen Vinyl Flooring

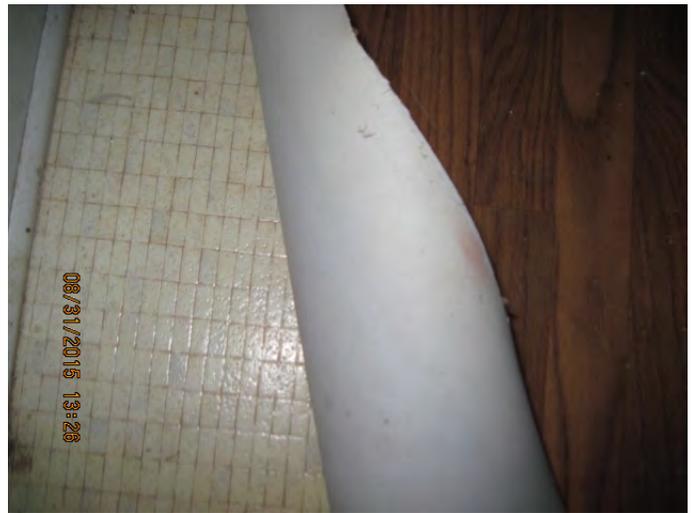
Photo 4 – Two Layers Bathroom Vinyl Flooring

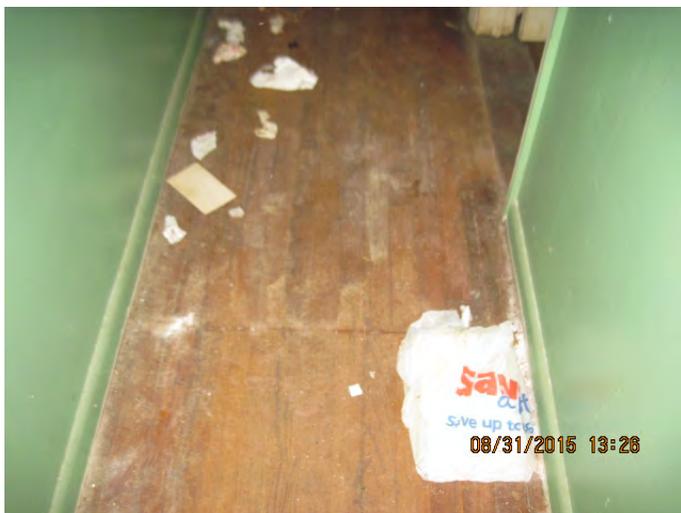
Photo 5 – Hall Wood Flooring

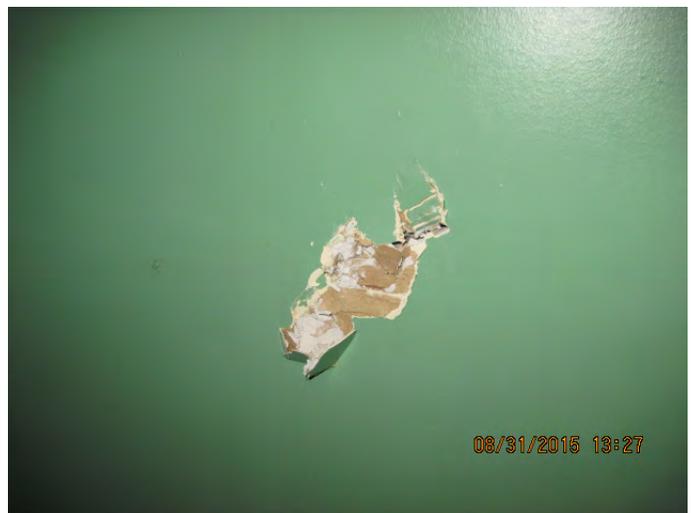
Photo 6 – Drywall
