Asbestos & Lead Based Paint Assessment

City of Spartanburg
444 Tryon Street
Spartanburg, South Carolina

Project Number: 0815-163

September 16, 2015

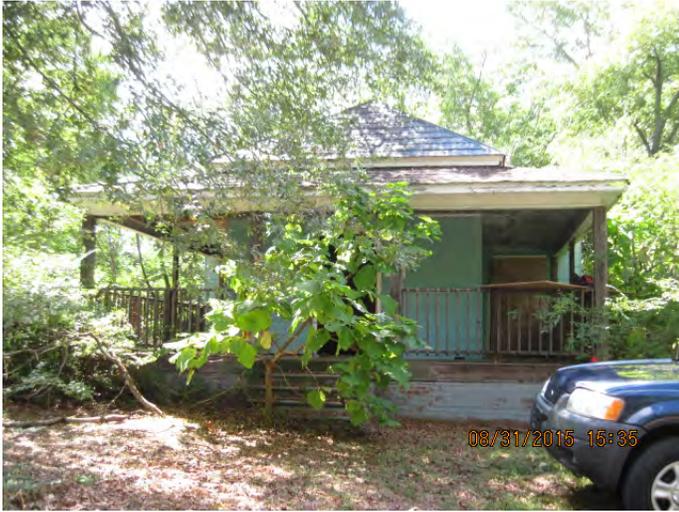
Photo 1 -- Front Elevation

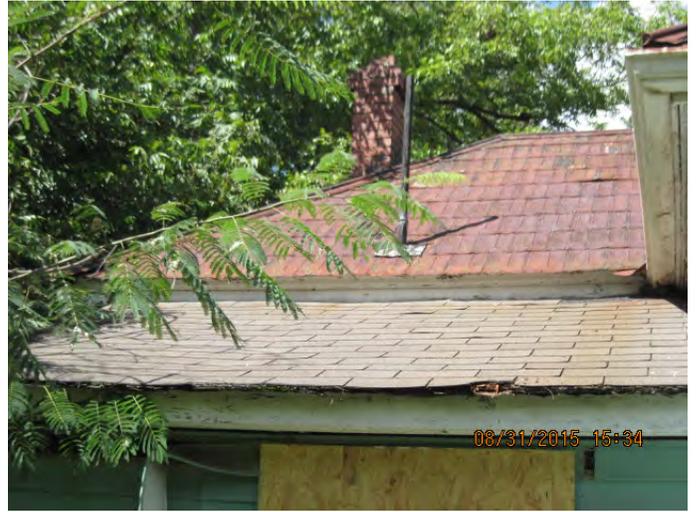
Photo 2 – Metal and Shingle Roofing

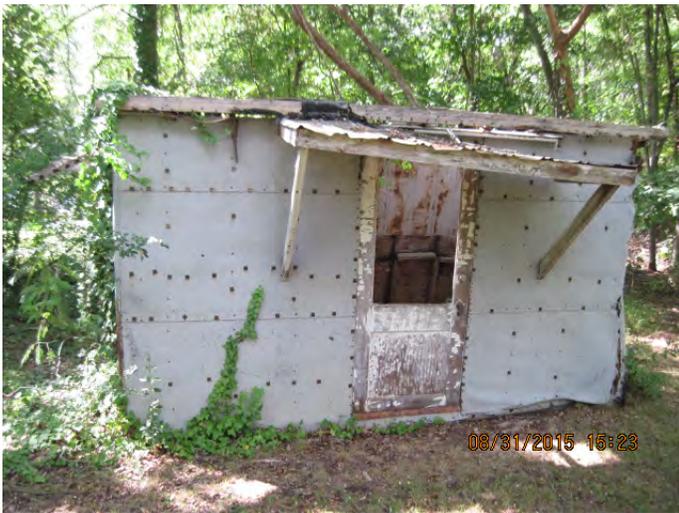
Photo 3 – Exterior Shed

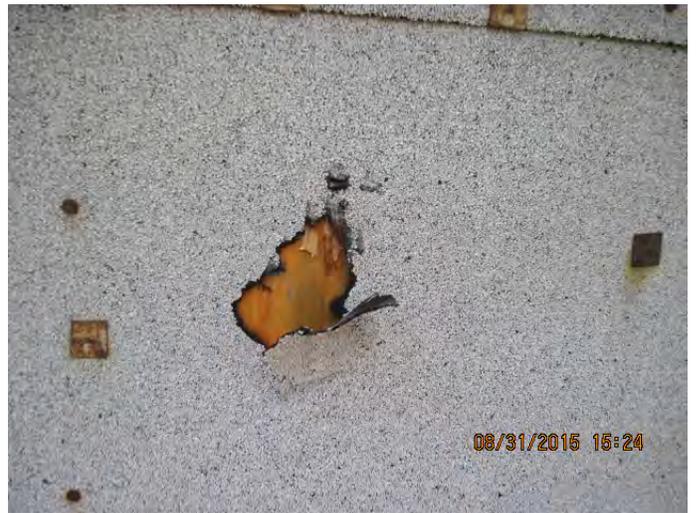
Photo 4 –Shed Shingle Siding

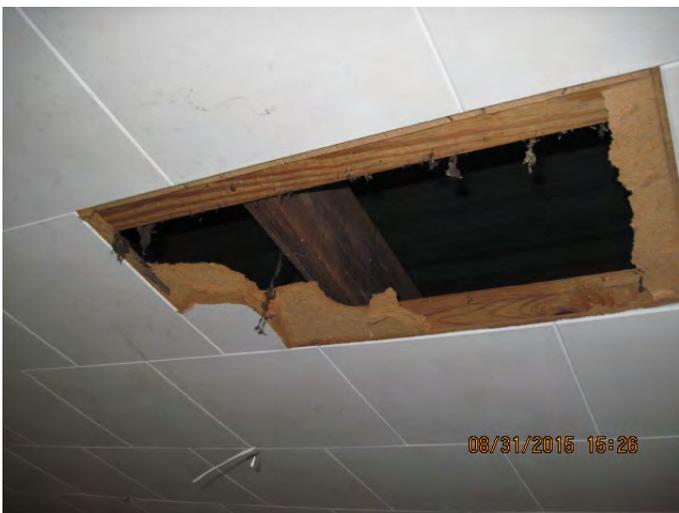
Photo 5 – Composite Wood Ceiling Tiles

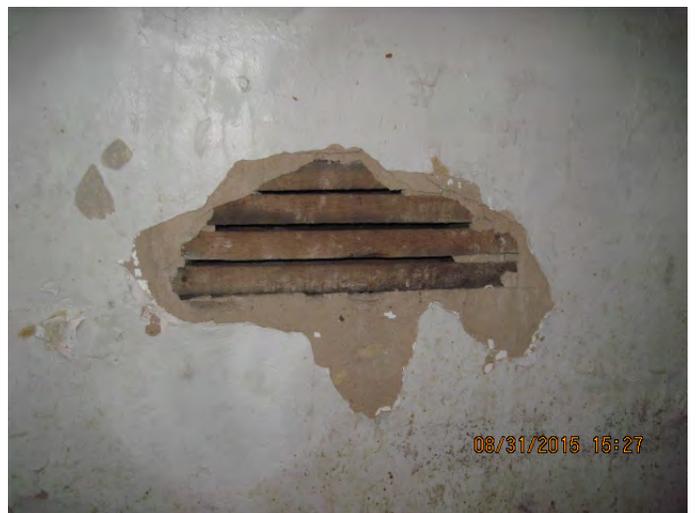
Photo 6 – Plaster Wall

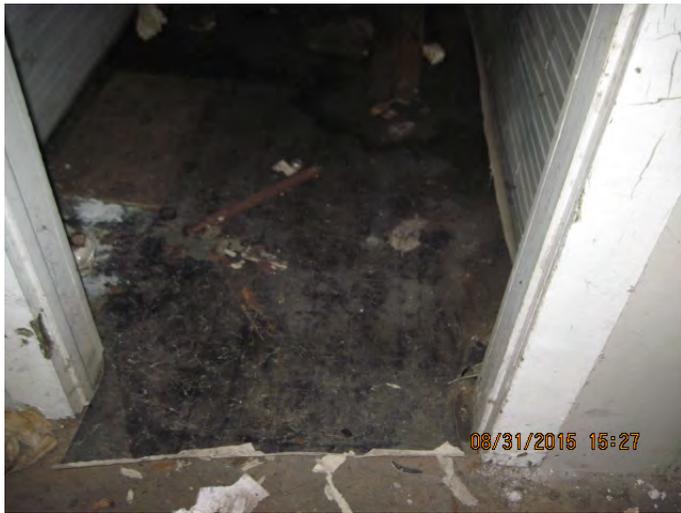
Photo 7 – Closet Vinyl Flooring

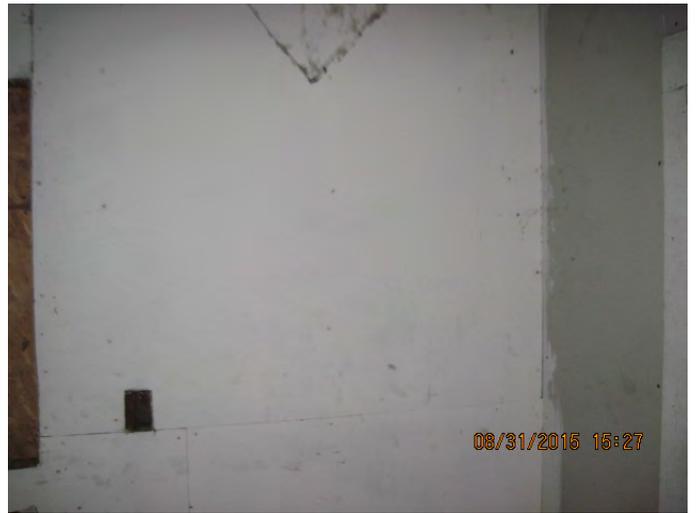
Photo 8 – Drywall with No Joint Compound in Addition Area.

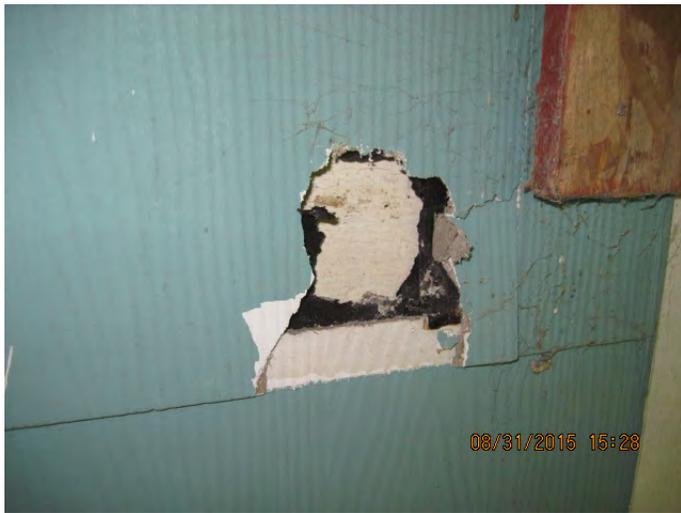
Photo 9 – Cement Board Siding with Felt

1. Abate the asbestos containing materials in the structure prior to renovation or demolition.
2. Follow applicable asbestos regulations during renovation or demolition of the structure. You should be aware that stringent requirements are imposed upon anyone renovating or demolishing a structure in which ACM will be disturbed. This work must be performed in accordance with OSHA asbestos regulations, 29 CFR 1910 & 1926, and NESHAP asbestos regulations 40 CFR 61, subpart M. South Carolina regulations require the accreditation of personnel who work in the asbestos field and notification and permitting fees for asbestos removal projects. There is a 10 working day notification period required prior to abatement of asbestos in a facility. Failure to take proper precautions and actions to protect human health and the environment can result in penalties, danger to personnel, and construction delays.

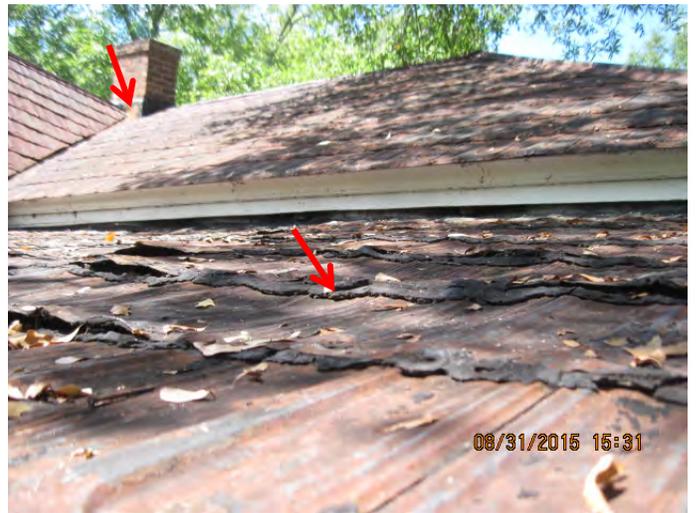
Photo 10 Assumed Chimney Tar and Metal Roof Tar

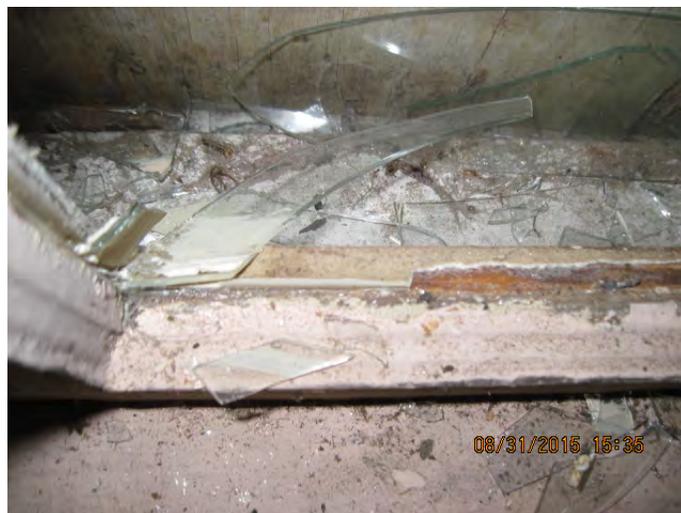
Photo 11 – Window Caulk
