Asbestos Containing Materials Assessment

631 Fulton Avenue
Spartanburg, South Carolina

Project Number: 0615-124

787 N. Vernon Street
Spartanburg, South Carolina

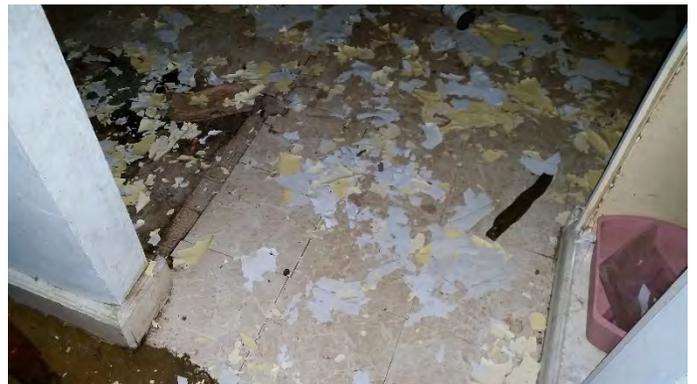
Photo 6 – Kitchen

- Approximately 90 SF of Linoleum (Double Layered) located in the Kitchen.
- Approximately 800 LF of window glazing located on the exterior.

1. Abate the asbestos containing materials in the structure prior to renovation or demolition.
2. Follow applicable asbestos regulations during renovation or demolition of the structure. You should be aware that stringent requirements are imposed upon anyone renovating or demolishing a structure in which ACM will be disturbed. This work must be performed in accordance with OSHA asbestos regulations, 29 CFR 1910 & 1926, and NESHAP asbestos regulations 40 CFR 61, subpart M. South Carolina regulations require the accreditation of personnel who work in the asbestos field and notification and permitting fees for asbestos removal projects. There is a 10 working day notification period required prior to abatement of asbestos in a facility. Failure to take proper precautions and actions to protect human health and the environment can result in penalties, danger to personnel, and construction delays.

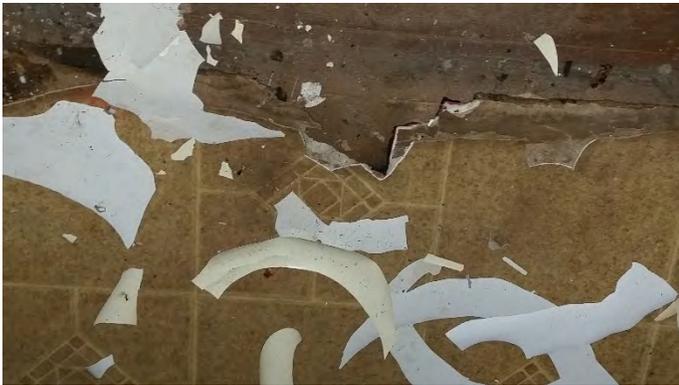
Photo 3 – Multiple Layers of Flooring in the Kitchen

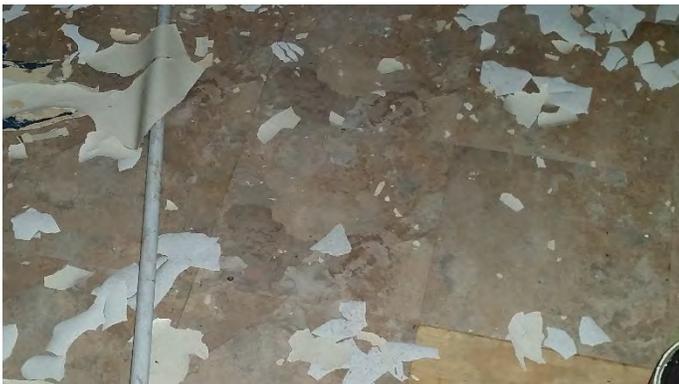
Photo 5 – Marbled Tile in Bathroom

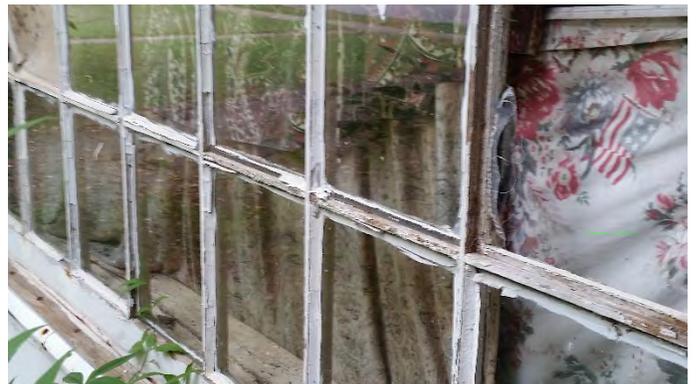
Photo 6 – Window Glazing

Sample No.	Location	Sample Description	Analytical Results	Friable/Non Friable	Condition	Quantity
1	Exterior	Transite Siding	8% Chrysotile	Non-friable	Good	2,000 SF
2						
3						
4	Exterior	Window Glazing	2% Chrysotile	Non-friable	Good	500 SF
5						
6						
7	Rear Porch	Ceiling Tile over Window	NAD	Friable	Good	12 SF
8						
9						
10	Bath	12" x 12" Marbled Floor Tile	NAD	Non-friable	Good	38 SF
11						
12						
13	Kitchen	Multiple Layer Flooring	5% Chrysotile (Tan Layer)	Non-friable	Good	176 SF
14						
15						
16	Rear Porch	12" x 12" Tan Floor Tile	3% Chrysotile (Tile) 2% Chrysotile (Mastic)	Non-friable	Good	76 LF
17						
18						
19	Throughout	Plaster	NAD	Friable	Good	2,800 SF
20						
21						
22						
23						
24	Exterior	Shingle & Felt (4 layers - shingle)	NAD	Non-friable	Good	1,500 SF
25						
26						
	Exterior	Chimney Caulk	Assumed Positive	Non-friable	Good	12 LF
